BEFORE THE  
FEDERAL COMMUNICATIONS COMMISSION  
WASHINGTON, D.C. 20554

ARKANSAS CABLE  
TELECOMMUNICATIONS  
ASSOCIATION; COMCAST OF  
ARKANSAS, INC.; BUFORD  
COMMUNICATIONS I, L.P. d/b/a  
ALLIANCE COMMUNICATIONS  
NETWORK; WEHCO VIDEO, INC.; and  
TCA CABLE PARTNERS d/b/a COX  
COMMUNICATIONS,

Reply Declaration of Michael T. Harrelson, P.E.

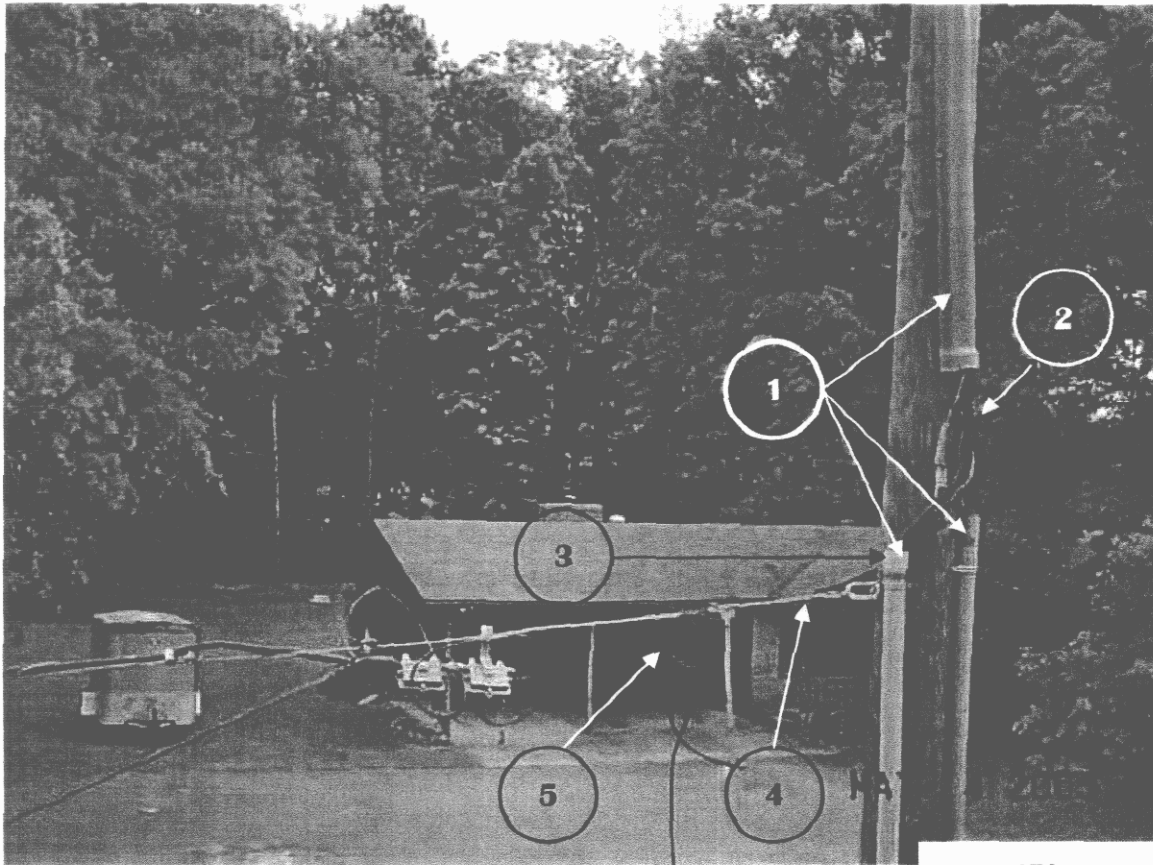
-47A-

This is a pole that Cox asked Entergy to replace for its upgrade in Malvern. It is a brand new pole, so EAI was starting with a clean slate. The first problem is that EAI has installed the riser conduits poorly (Arrow #1). The black cables visible in the photos are hot electric cables leading from a transformer at the top of the pole to an underground electric service installation (Arrow #2). The top of the conduit (Arrow #3) is about two or three inches from Cox's cable TV facility (Arrow #4). The dangling wire visible about a foot to the left of the pole (Arrow #5) is one of Cox's customer service drops that Entergy did not re-connect after it replaced the pole and took the liberty to transfer Cox facilities. Another major problem is that this is a dead-end pole, that EAI did not guy. All dead-end poles must have guys to balance load tension.

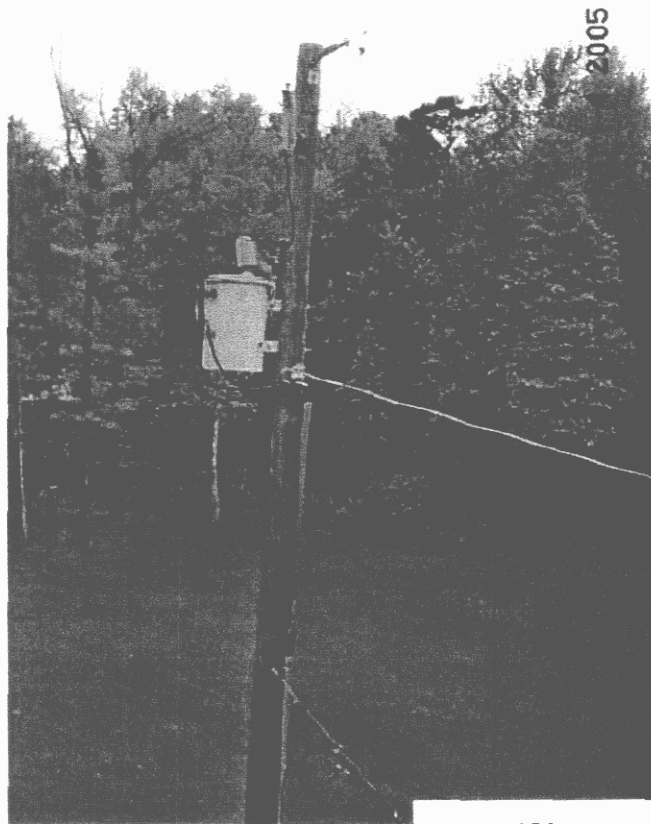
As is clear from this photo of the same pole depicted in the previous photo there is no guy and the pole is already leaning. This situation will get worse over time. Lines will sag, possibly creating hazards with traffic beneath the span. The pole could eventually fall down.

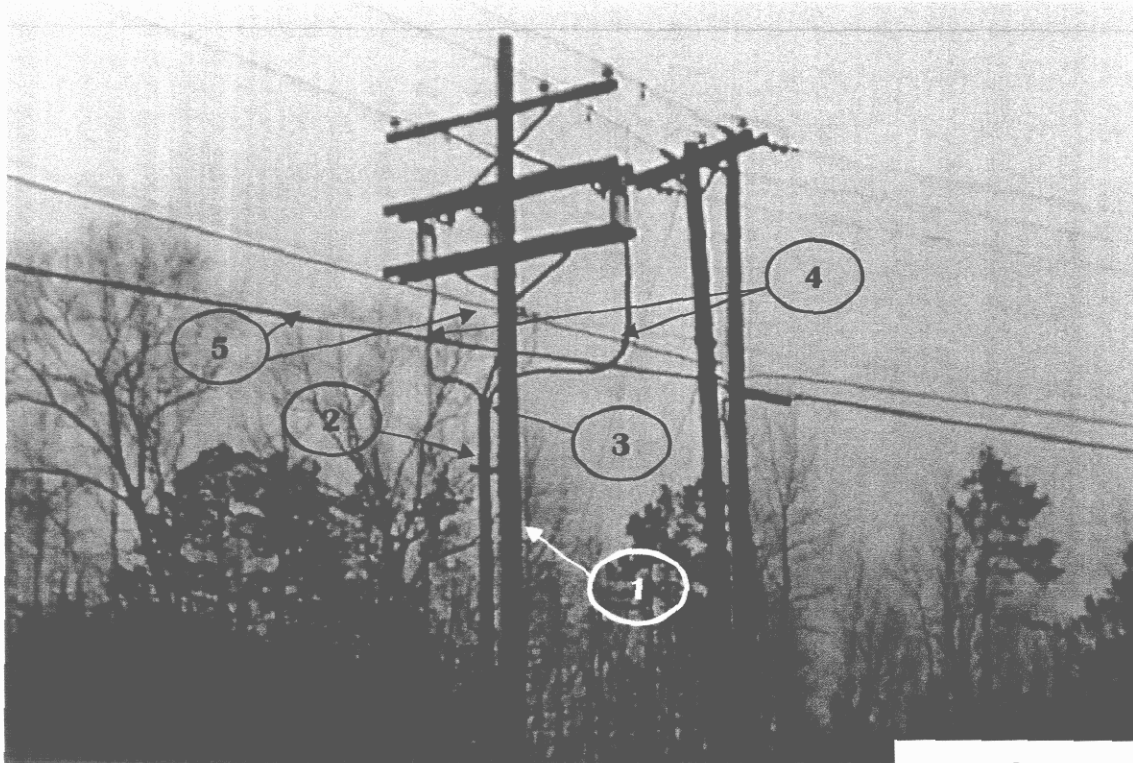
- 49A -

This new pole (Arrow #1) and high voltage primary cable riser (Arrow #2) was installed by EAI. The riser pipe (Arrow #3) stopped below cable (Arrow #4), not 40 inches above as EAI insists is their mandatory standard. The electric cable then flared out from the riser, completely surrounding the cable TV facility (Arrow #4). Comcast ultimately was able to extricate its facilities, but only by cutting them down – a very expensive and wasteful operation that could have been avoided if EAI had sought to notify attachers of this new installation and coordinate the project. This photo was taken at the direction of Marc Billingsley of Comcast.

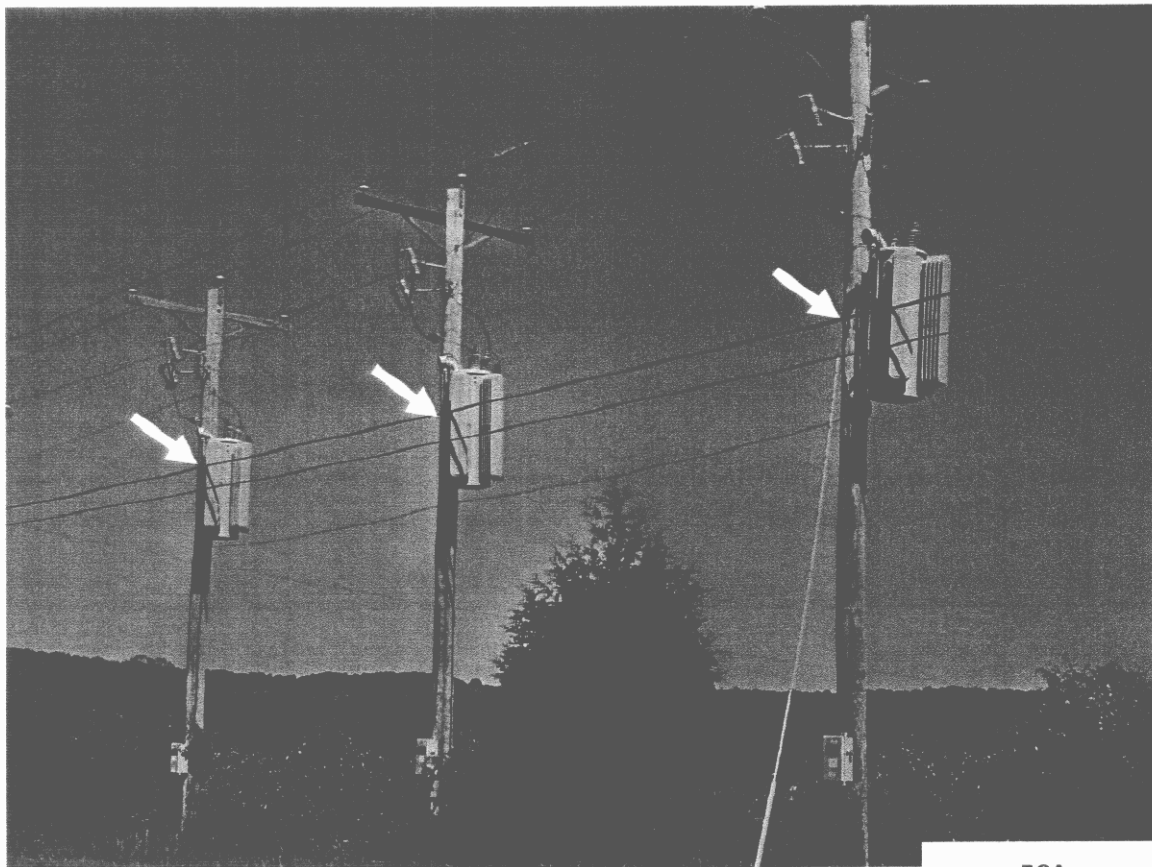
- 50A -

These photographs were taken at the direction of Jeff Gould of Cox in that company's Russelville system. Here, the power company very recently has (1) installed new poles; (2) put up three step voltage regulators, and (3) put the regulator tanks into direct contact with the pre-existing communications lines. The communications cable near the top of the long regulator tanks is much less than 40 inches to the exposed high-voltage wires and connections on top of the regulator tanks and within easy reach of workers and sudden death. In addition, the neutral that according to EAI must in all cases be 40 inches *above* communications, EAI actually installed several feet *below* communications. But the communications lines are not connected to these poles and are merely rubbing against these regulator tanks. This is obvious from the next photo.

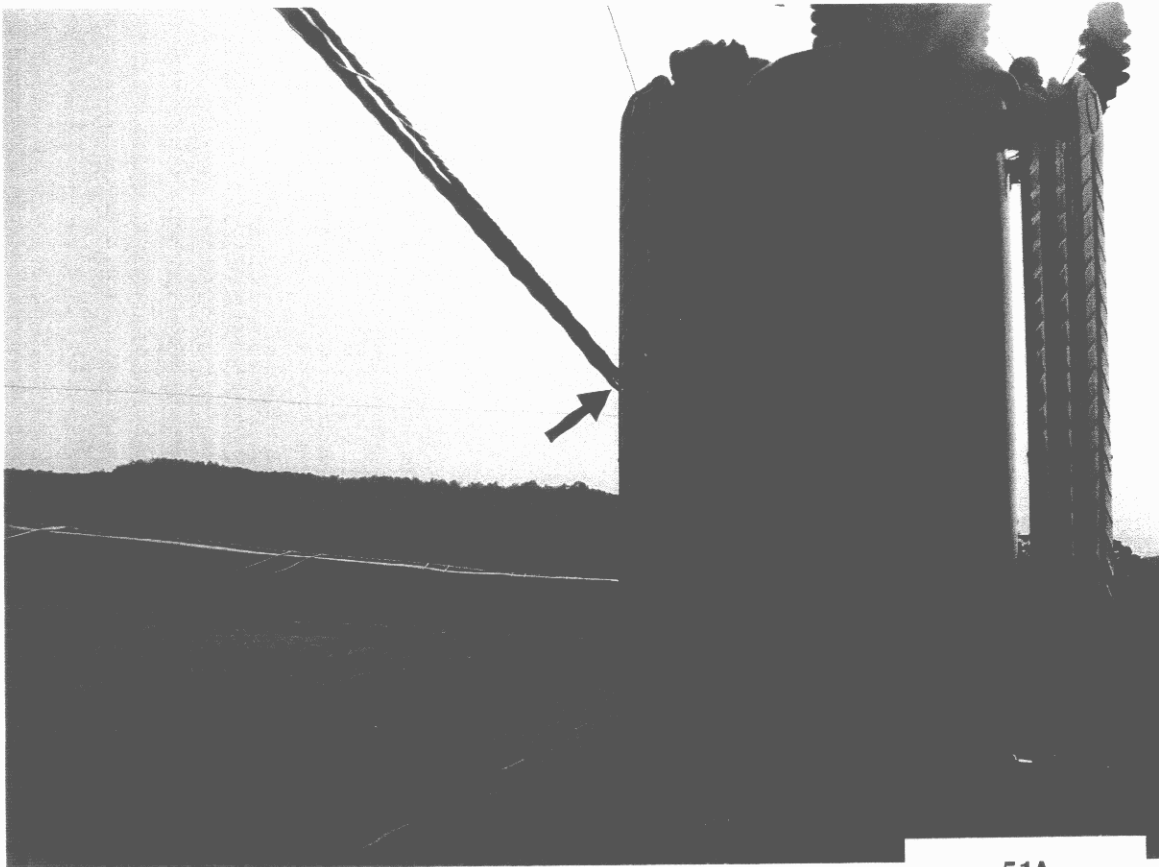
- 51A -

This photo was taken at the direction of Cox's Jeff Gould.

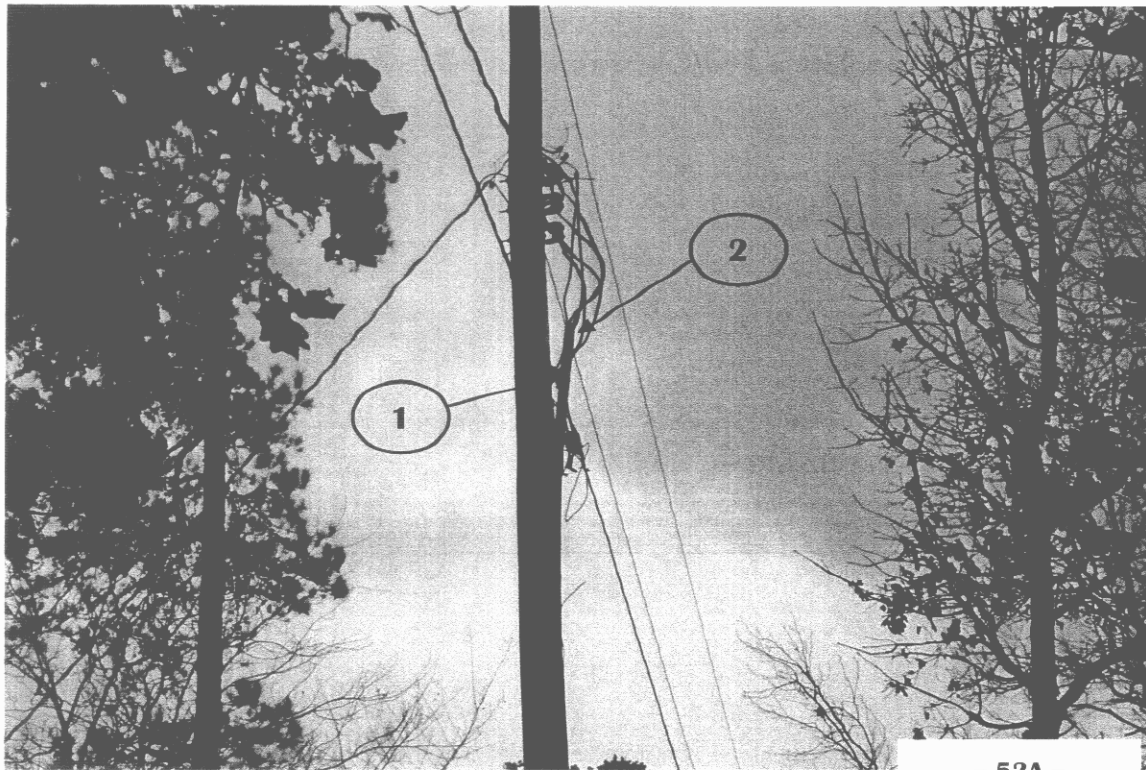
- 52A -

This photo depicts a typical EAI configuration in Arkansas. Not only has the power company installed the electric riser and conduit literally on top of the cable television facilities (Arrow #1), but the riser is too short (Arrow #2), creating multiple violations of the electric-to-communications clearance standards of the NESC. Note also the “fly-away” appearance of the riser conduit. These electric cables above the riser pipes, which pin cable television poles and preventing CATV workers from accessing facilities without touching power, should be corrected immediately by EAI. This photo was taken at the direction of Marc Billingsley of Comcast.

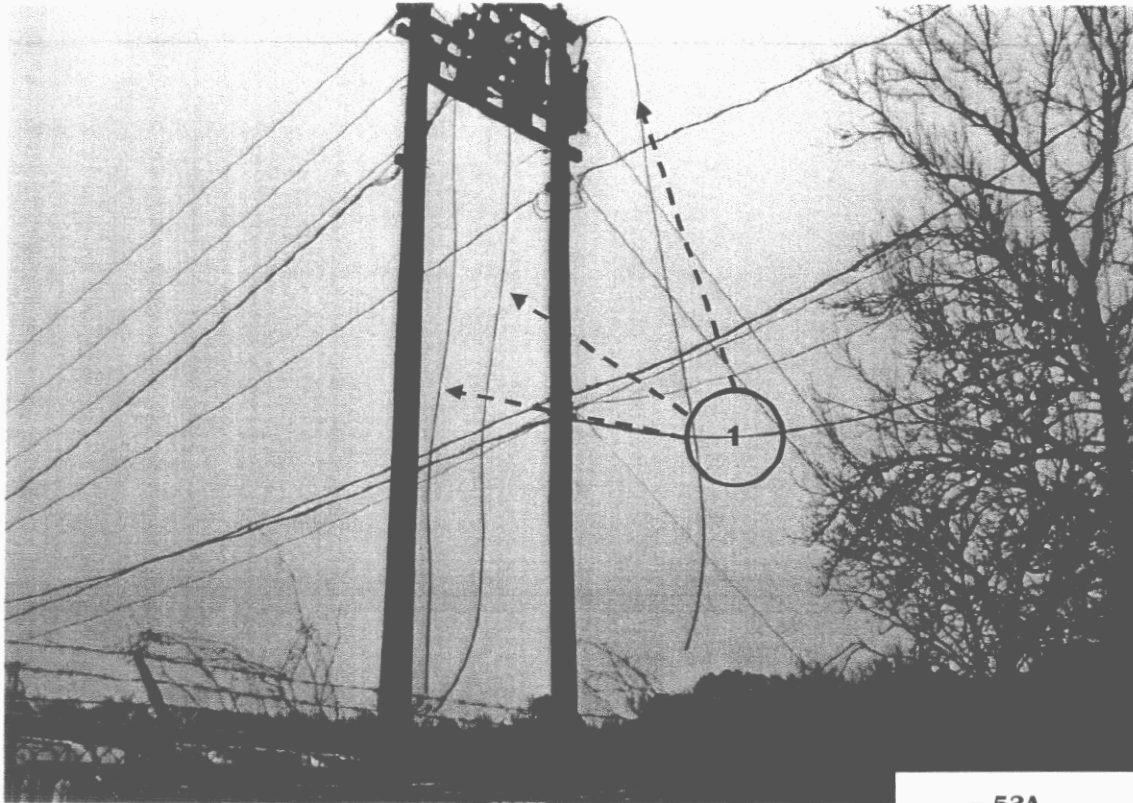
- 53A -

This photograph which was taken at the direction of Marc Billingsley of Comcast, shows dead primary lines hanging down (Arrow #1) from the top of high-voltage power distribution poles near an abandoned bicycle factory at 6301 Patterson Road in Little Rock. The power lines, even though apparently de-activated, create a dangerous situation because they touch the cable television support strand and they hang down low to the ground. The work rules of the NESC apply to electric workers and communications workers. They do not permit workers to treat such lines as dead unless they are disconnected from the source, tested for absence of voltage and grounded. Further, NESC rule 214.B.3. states that lines permanently abandoned shall be removed or maintained in a safe condition. These abandoned lines create serious hazards for workers and the public.

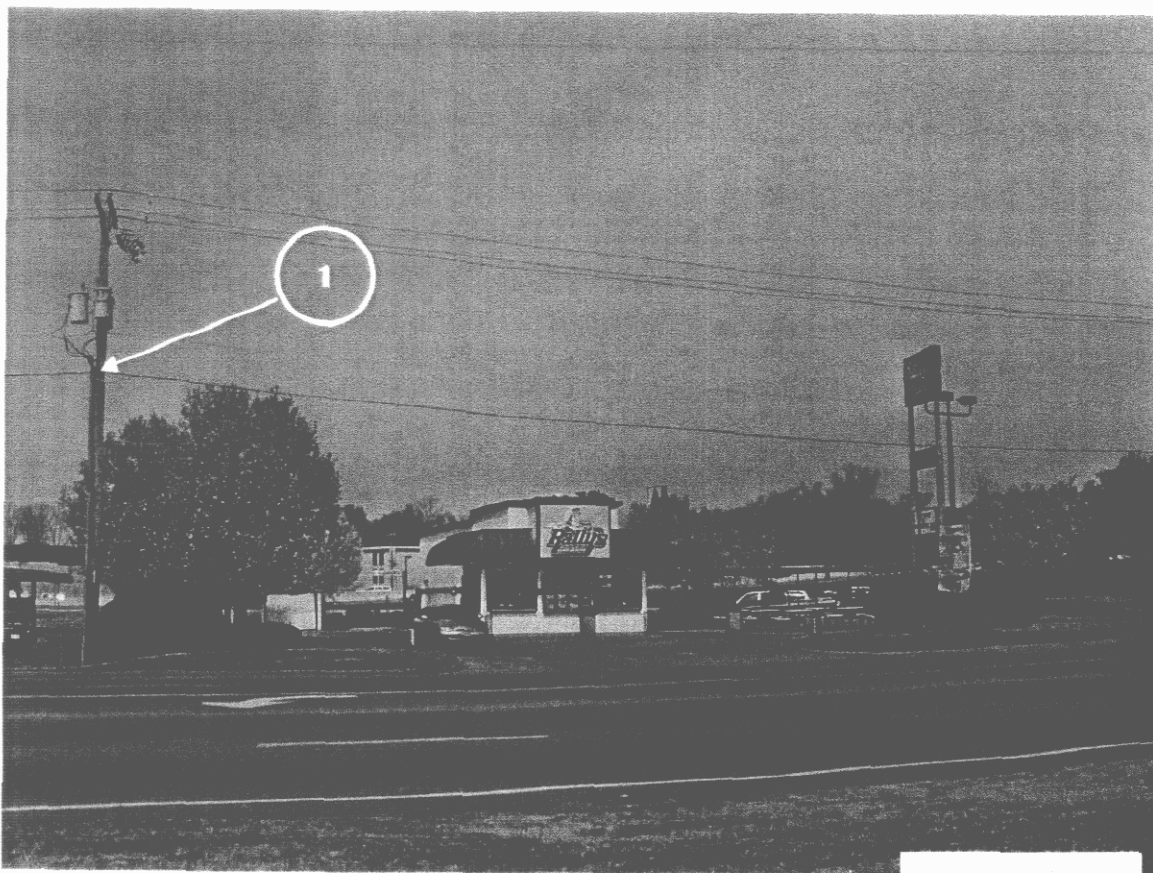
- 54A -

This photo, which I took, shows a pole at the left where there is a new underground electric service riser, with the riser pipe stopped about 4 inches above the cable television facilities (Arrow #3). EAI could have easily installed this service riser to a place above the neutral wire, which would meet the NESC 40" requirement. I was present during a make ready field meeting held on March 24, 2005 to accommodate a project for another communications company in the area needing access to EAI poles. At that meeting EAI and USS told Comcast that they would not extend this riser and would not accept responsibility for fixing the violation that it created. Location: Jacksonville, AR, N. First ST.

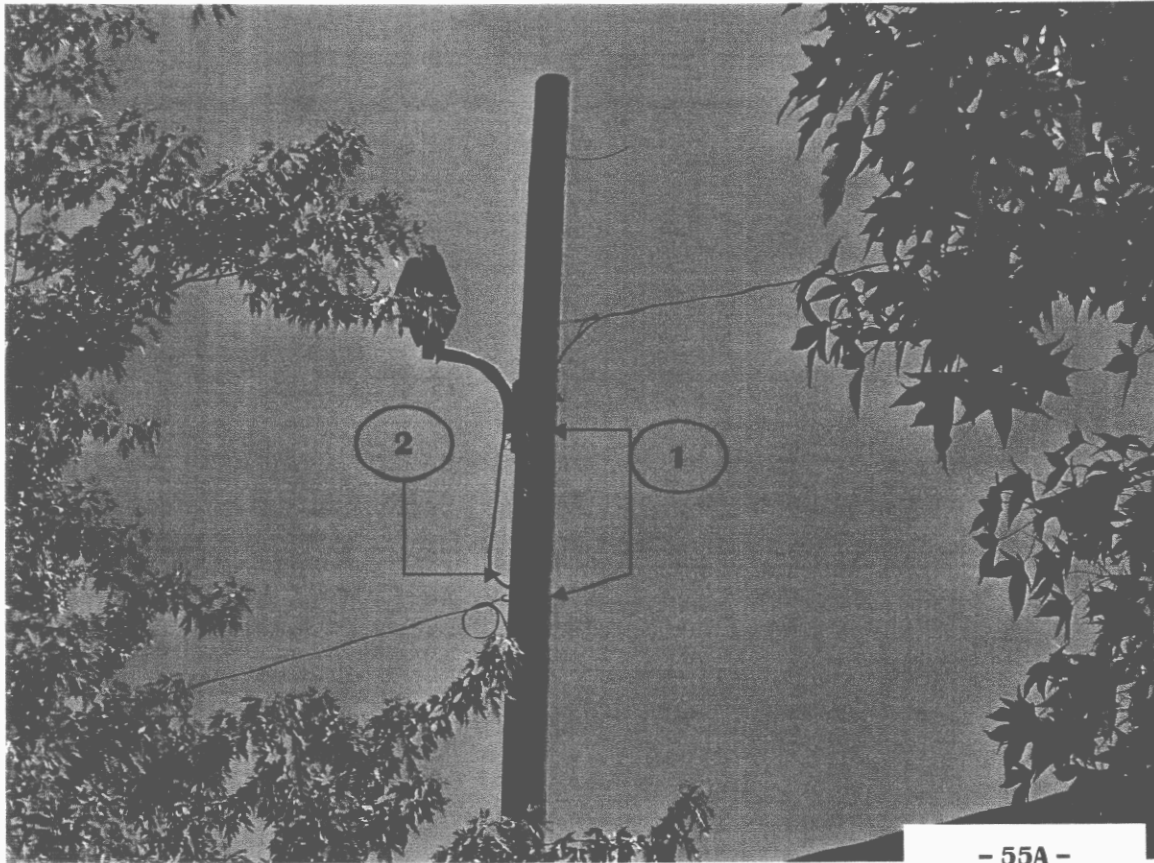
This new street light illuminates the parking lot at the Comcast building in Little Rock. There is ample separation between the light bracket and the communications drop (Arrow #1) but EAI has built this new light with excessively long power leads (Arrow #2), hanging down closer than 12 inches above communications. Location: Little Rock, Enmar Dr.

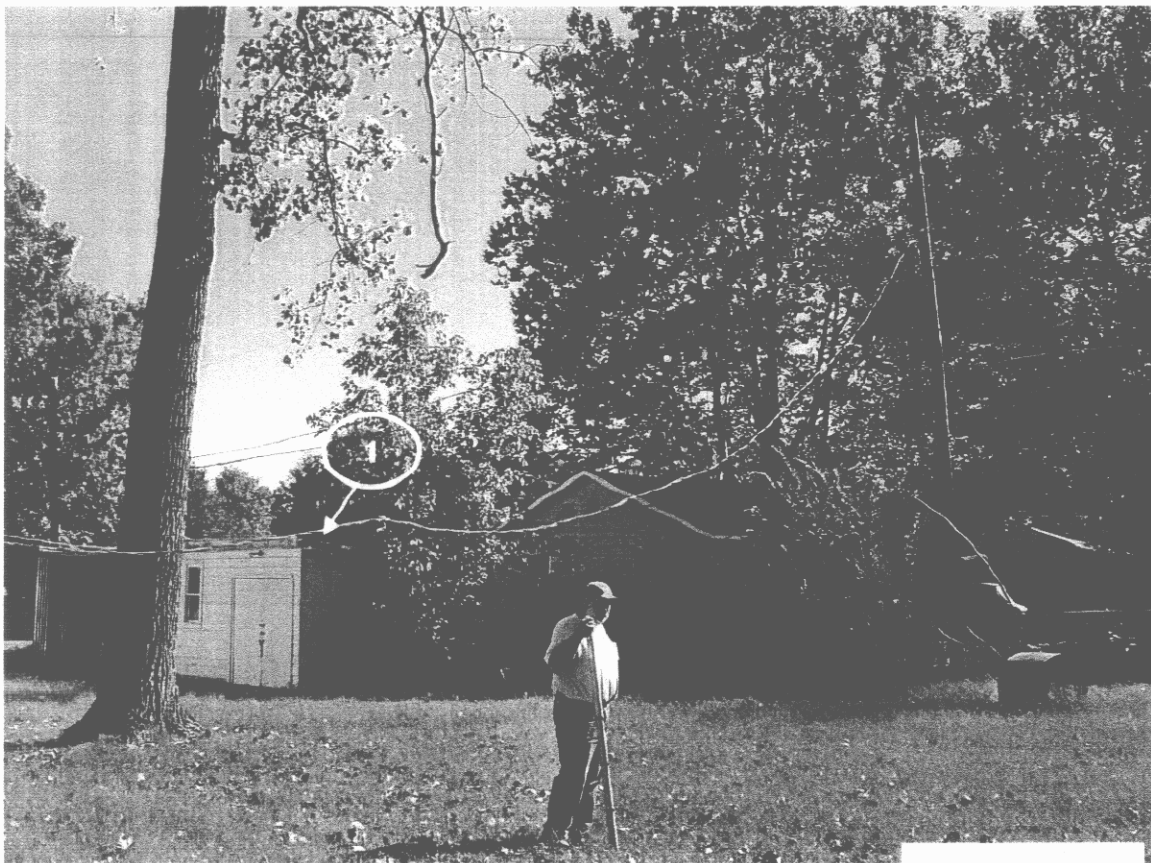
- 56A -

The power lines in this photo, which I took, are along back lot lines between houses. This power drop (triplex cable, 240/120 volts (Arrow #1)) has pulled loose from the house and is being held up by a Comcast drop wire to the same house. Good communications, cooperation and fairness help keep these types of problems from getting out of control. Location: Jacksonville, AR.

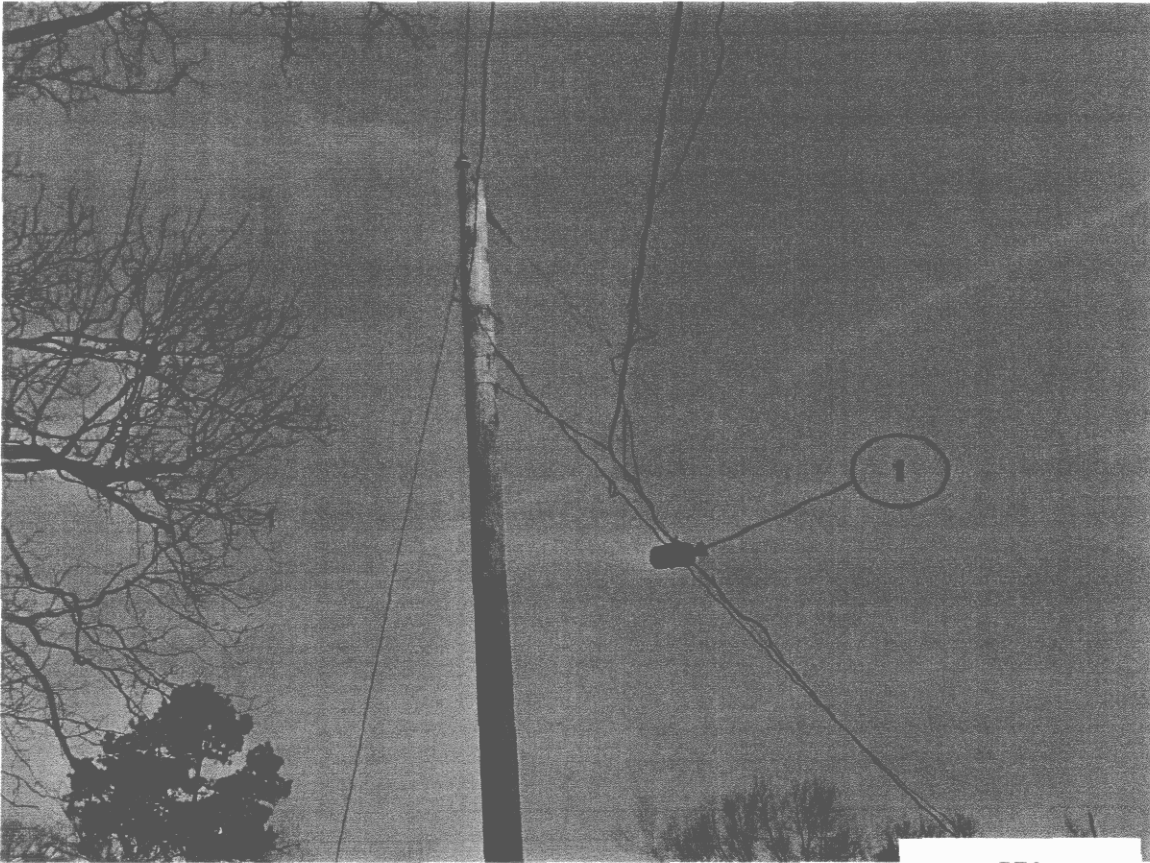
- 57A -

This photo, which I took, shows another EAI pole that apparently was broken by a vehicle. EAI tied Comcast's cable, plus a big chunk of the pole that it had sawed off from the old pole with a piece of scrap wire (Arrow #1). Comcast discovered this during a make-ready ride-out to assist another party in gaining access to Entergy poles in March 2005. This is a good example, and there are countless other ones, where EAI simply did not inform cable that it had performed work on the cable tv facilities. This continues to be a big problem. Location: Jacksonville Hwy 67/267.

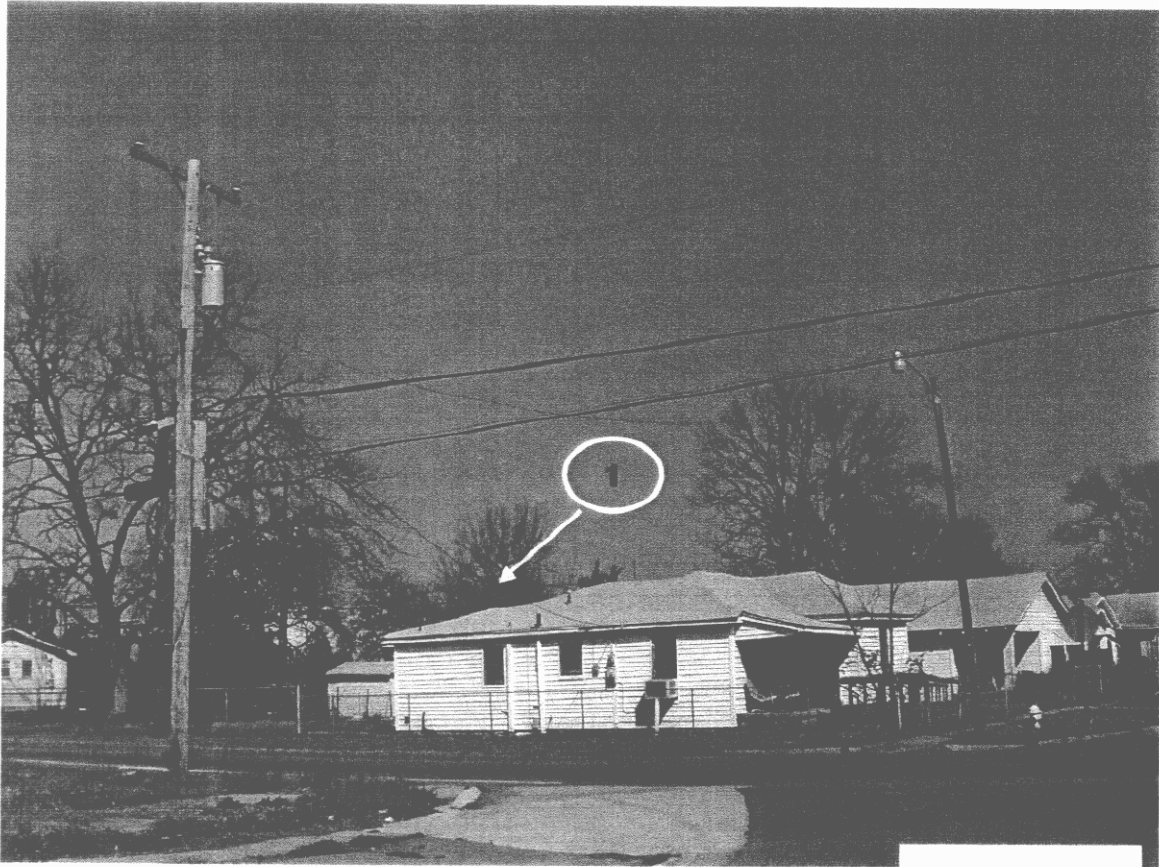
- 58A -

This photo, which I took, shows a very low electric service that is only 12 feet above the street (Arrow #1). NESC Rule 232 Table 232-1 requires it to be 16 feet. Unless it is raised, eventually a tall vehicle will pull this hot electric wire down. Location: Little Rock E. 11<sup>th</sup> St and J.L. Hawkins St.

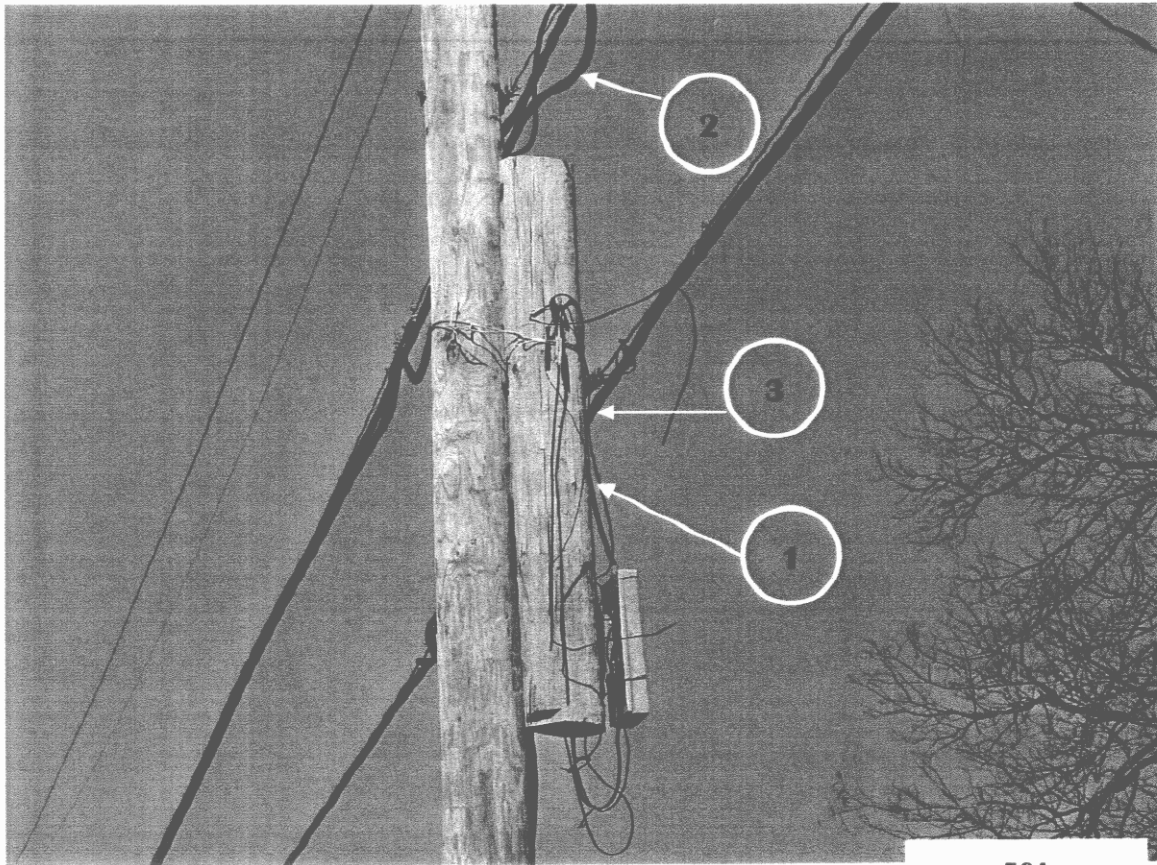
- 59A -

This pole, which is the same one as the prior photo shows a 5-foot length of the old broken pole, wired to the new pole by EAI (Arrow #1). You can see that the cable company has transferred its facility (Arrow #2) from the old pole to the new pole, but that the telephone company (Arrow #3) has not. Comcast notified EAI of this hazard, which EAI most likely created in conducting an emergency repair to the pole after a vehicle collision. Location: Little Rock E. 11<sup>th</sup> St and J.L. Hawkins St.

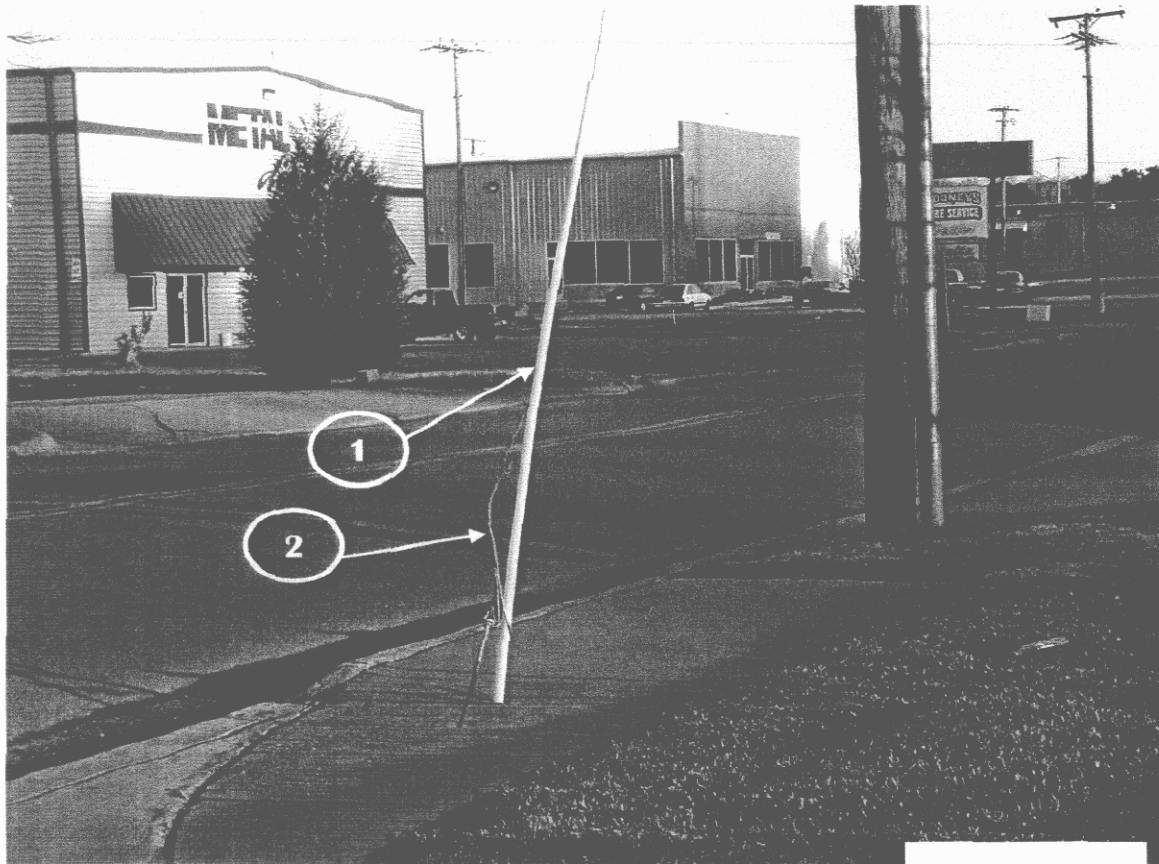
- 60A -

This photo, which I took, shows where EAI placed a new bright yellow guy marker (Arrow #1) on its steel down guy, but ignored the much more serious issue of the slack down guy that was providing no stability or support to the pole. In fact the guy was so slack the guy marker could not stay on properly (Arrow #2). The next pole in the span also contained a slack guy, which caused the two poles to bend in toward one another creating unacceptable slack in the span. Location: Little Rock, Enmar Dr.
